# Manhole Inspection Summary

Manhole # S29AA1003MH

Insp Date: **12/11/06 9:55 AM**

**Location** Address: **3402 BEECH AVE**

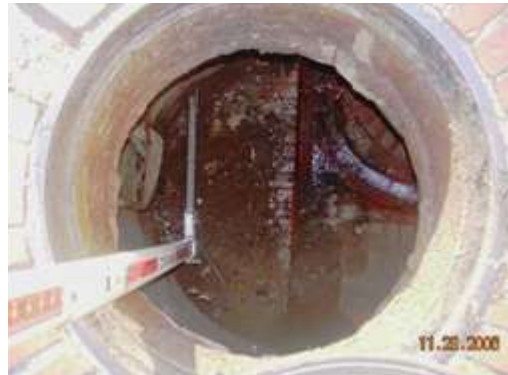
Top View

Evidence of surcharge - Bench debris.  
Corroded step. Channel debris.

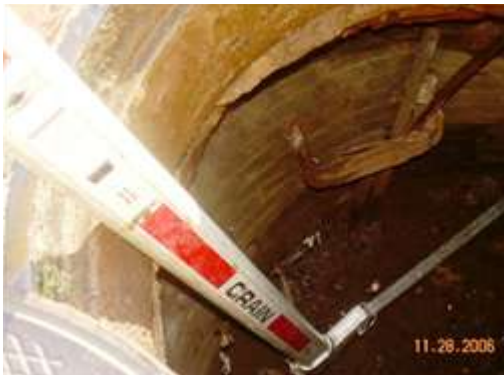
Defect

Frame leaks. Adjustment deterioration  
and infiltration. Corbel and Barrel  
infiltration. Corroded steps.

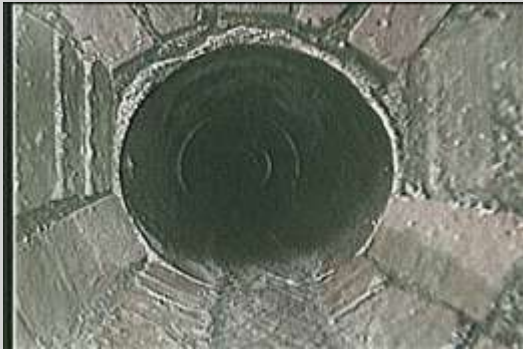
### 8 in. Circular Gravity Sewer Pipe Out @ 12 O'Clock

Infiltration: **Evidence** Pipe Seal Cond: **Unknown**

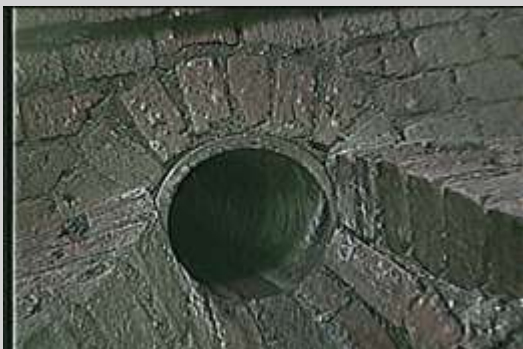
### 8 in. Circular Gravity Sewer Pipe In @ 3 O'Clock

Channel deterioration.

Infiltration: **None** Pipe Seal Cond: **Cracked**

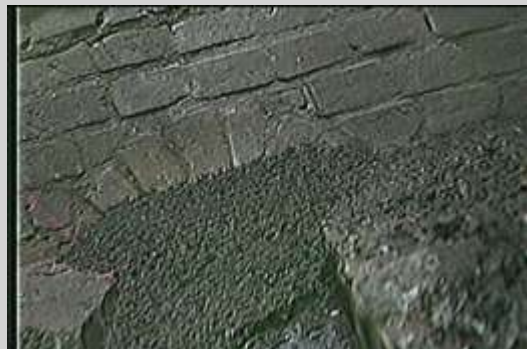
## Pipe In @ 6 O'Clock

STUB CONNECTION/ABANDONED.
